From: "Glenn MacEachern" <glenn@ecoglass.ca>
Subject: RE: ECO Insulating Glass - PROBLEMS
Date: 14 March 2017 at 21:36:34 GMT+1
To:
Reply-To: <glenn@ecoglass.ca>

From: Walter Frank Westgeest <westgeest@bouwkans.nl>
Subject: RE: Question
Date: 14 March 2017 at 17:07:48 GMT+1
To:
Cc:

This e-mail provides answers to the questions as asked by Eco Insulating Glass Inc. on March 9th and can be forwarded to them.

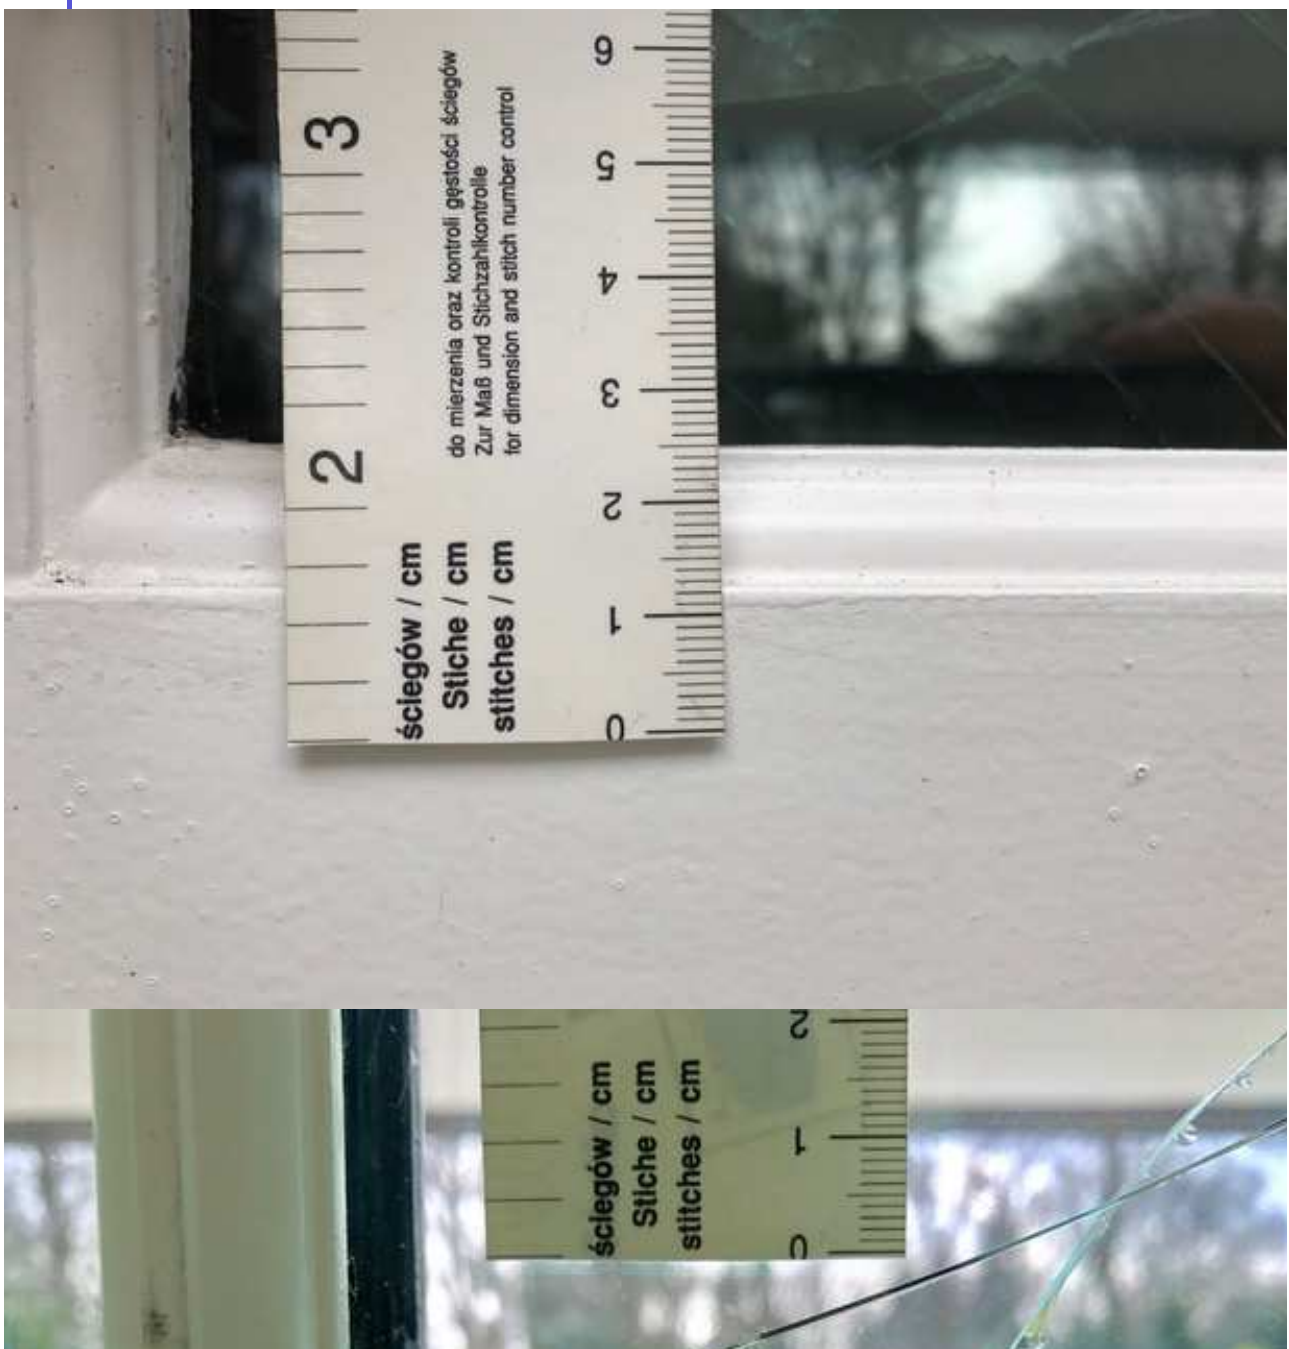
During my inspection no windows were found where – viewed from the outside and perpendicular to the pane – the primary or secondary sealants of the IGU were visible.

The glazing beads (outside stops) are of sufficient height to cover the complete edge system.

(photo 13).’ Because photo 13 was not taken perpendicular to the pane, two new photos (A and B) were taken (one from the inside and one from the outside). Due to the lighting conditions the photo from the outside shows the glass pane and background/inside as a dark area so that no details are visible. The photo from the inside is however very clear: the top sides of the glazing beads both inside and outside are visible and no sealants whatsoever are visible. Because all windows are similar no further photos were taken.

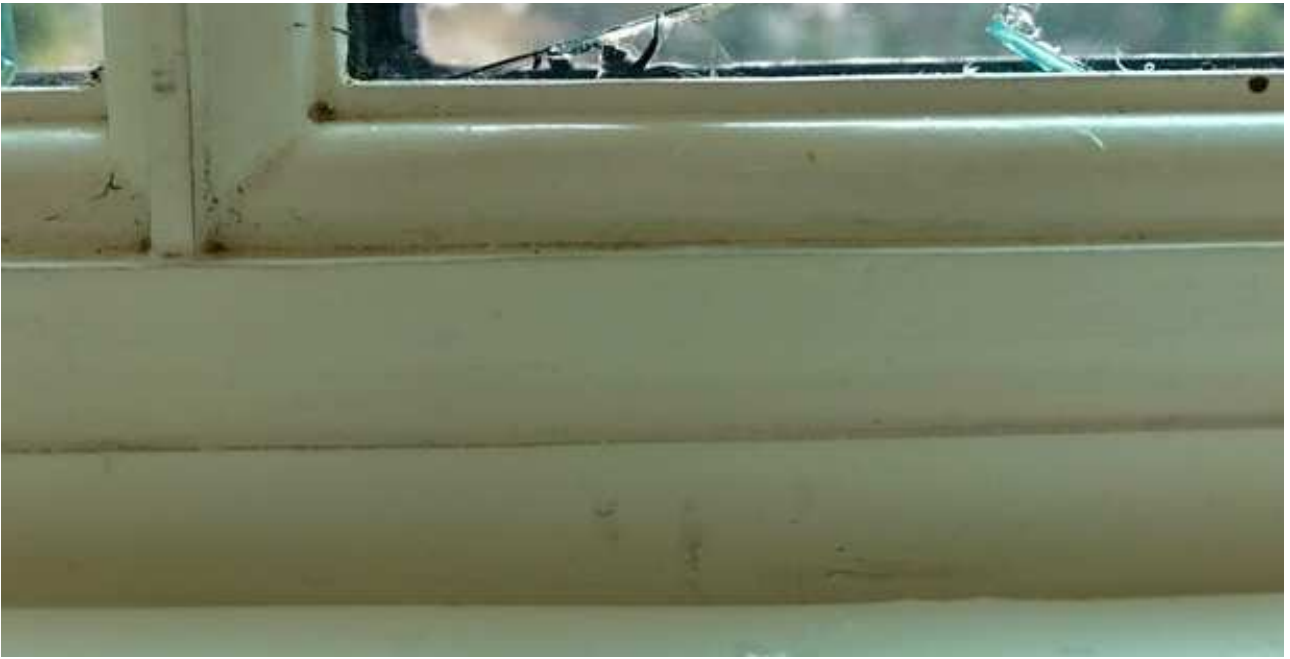
It???d be helpful if you were able to supply us close up photos of a few different windows - from the exterior of the residence - showing that the outside stops completely cover the sightline of the ~~Heat Mirror~~ insulated unit(s)

In other words showing that the black primary sealant (PIB in the attached diagram) and secondary sealants are not visible / exposed .
