From:
Subject: ECO Insulating Glass - PROBLEMS
Date: 17 May 2017 at 11:30:11 GMT+2
To: glenn@ecoglass.ca

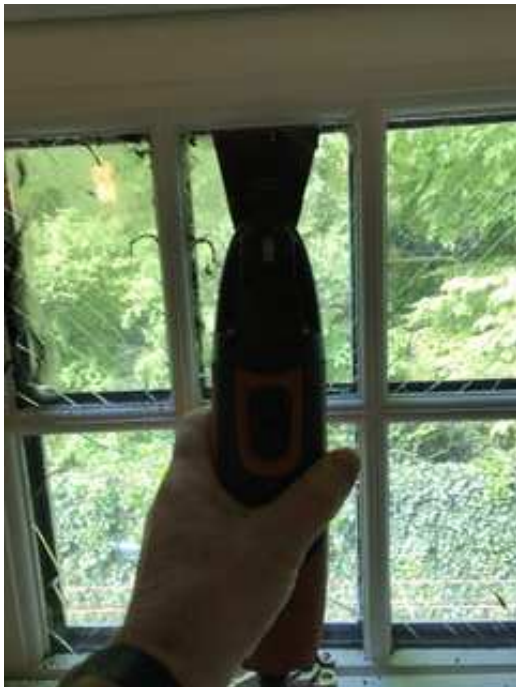
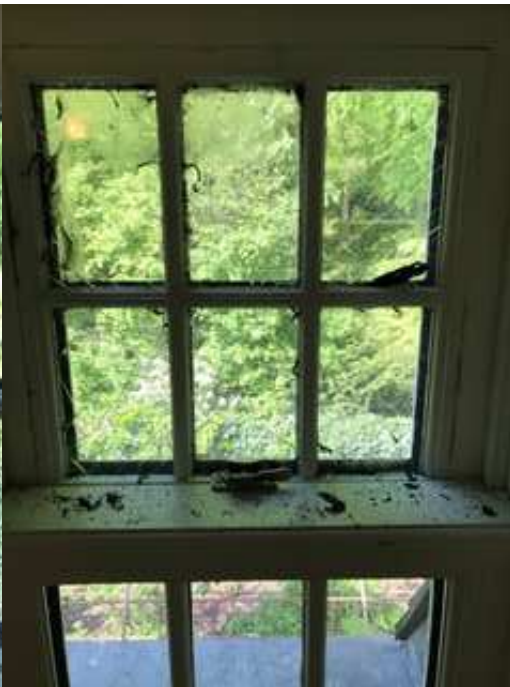
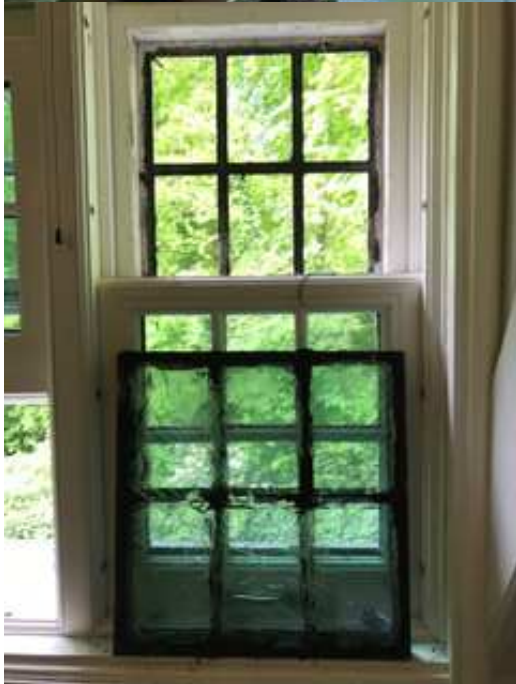
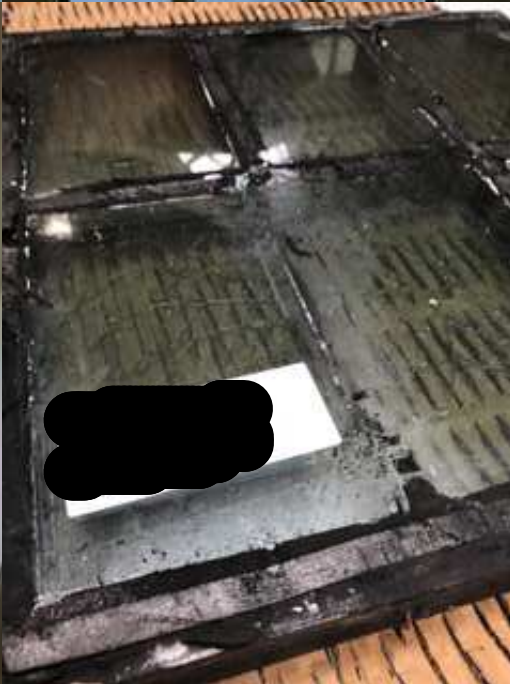
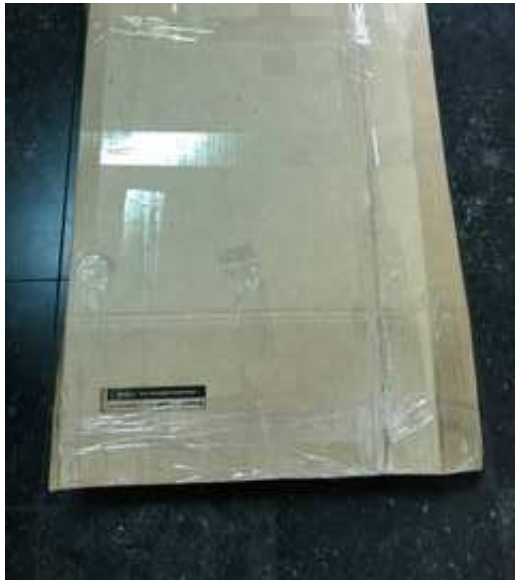
The imploded glass is ready for collection size 80cm x 55cm 8 kg from the address down below:

See photo's of the dismantling of the glass and ready for shipment:
