Client, in The Netherlands

Investigation of damaged Insulating Glass Units

17KB1-R1

February 10th, 2017

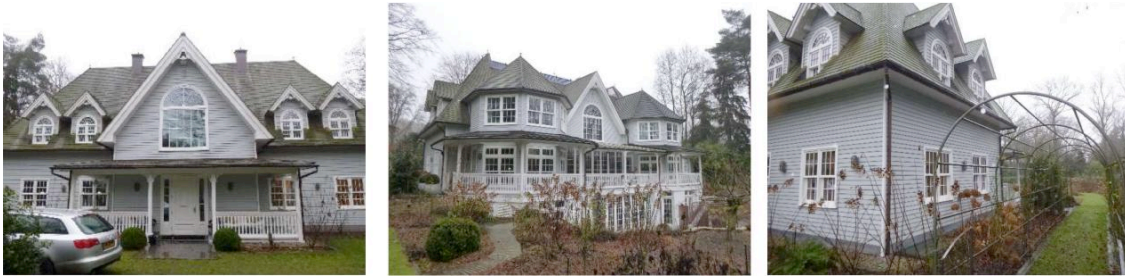
Photos 1, 2, 3: Front side of the villa is facing NNW, backside SSE, right side WSW.

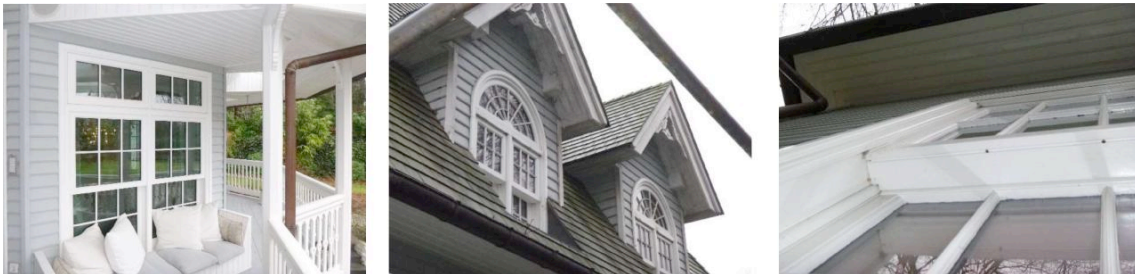
Photos 4, 5, 6: Shielding by canopies, eaves and gutters.

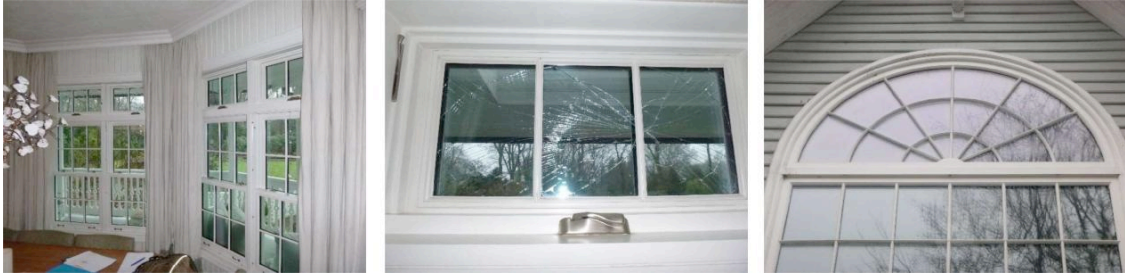
Photos 7, 8, 9: Bottom an top sash windows with hinged vent windows above them, fixed windows half round shaped windows. All with crossbars on both sides.

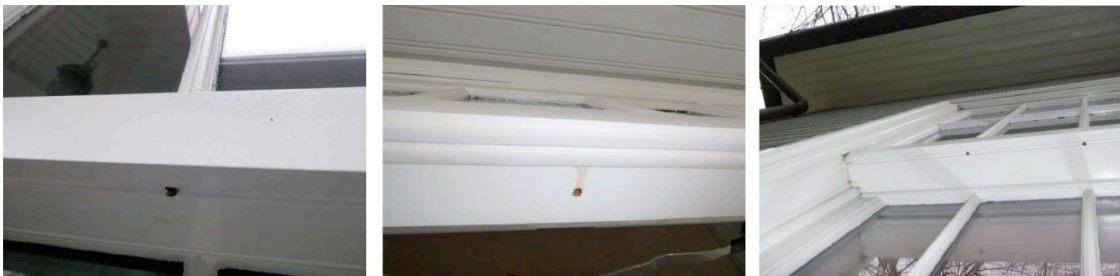
From the outside weep holes for water drainage are visible on the underside of all of the in-spected window frames (sash, hinged and fixed). The number of weep holes varies from 1-3 per window frame. The weep holes were not incorporated in the framing system originally but were, according to information provided by client, drilled before the IGUs were placed as advised by the workmen hired for placing the IGUs. The size of the weep holes is approximately 6 mm.

Photos 10, 11, 12: 1-3 weep holes for water drainage per window.

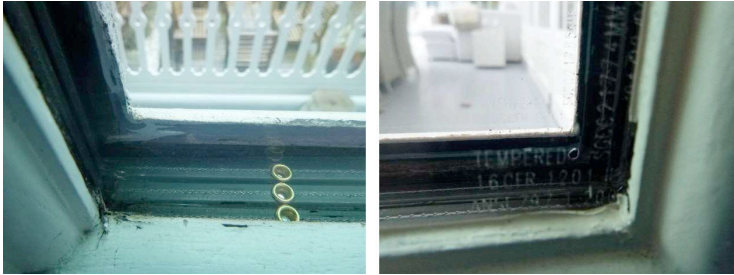
The combination of the rebate depth and the height of the beads is such that the glass unit edge, spacer and sealant is sufficiently recessed and not visible when viewed from the front (photo 13).

Photos 13, 14: Spacers and gas filling holes, inscription and holes in the foil.

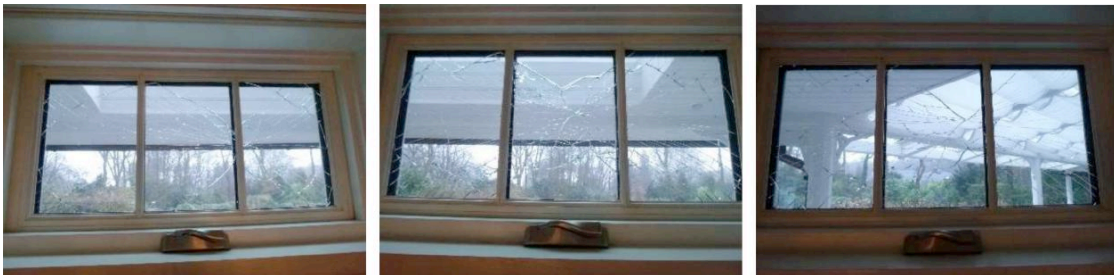
In total 7 broken glass panes were inspected, all of which were inside panes that had col-lapsed inwards (i.e. in the direction of the cavity). Most of the breaking patterns are very typi-cal for breakage due to an equally distributed load like exterior air pressure. No impact re-lated markings were observed.

Photos 15, 16, 17: Three imploded units (numbered 1, 2 and 3) with broken inside panes. All are hinged vent windows situated right under the large canopy on the back side of the villa (photo 4).

No known remedies exist for the diffusion/absorption process.
All IGUs must be replaced.

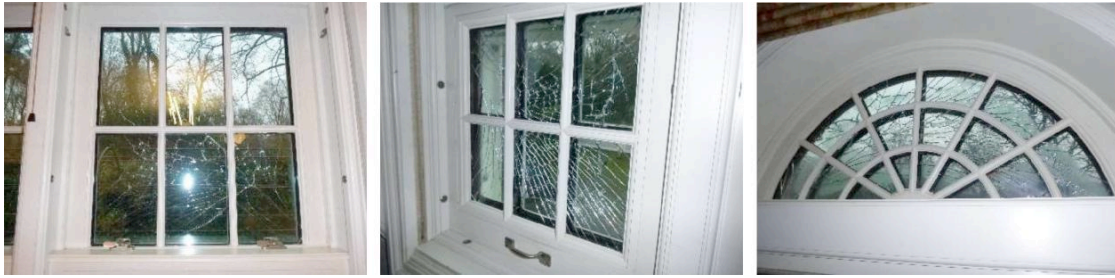
Photos 18, 19, 20: Three imploded units (numbered 4, 5 and 6) with broken inside panes. Situated respectively in a: top sash window ground floor in the office, bottom sash window and half round fixed window both in the same window frame at the first floor bedroom. All units are in the WSW facing (right side) façade.

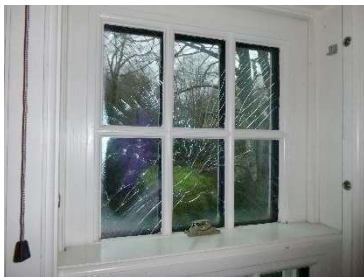
Photo 21: Imploded unit (numbered 7) with broken inside pane. Situated in a top sash window at the first floor bedroom in the SSE facing (back side) façade.

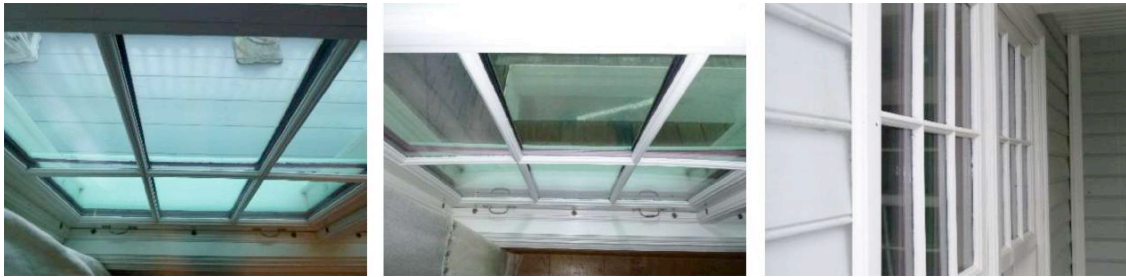
All of the inspected IGUs, except for one, had visible concave shaped glass panes. The in-side pane was always distorted considerably more than the outside pane. The quantity of dis-tortion varied considerably, but was clearly visible.

Photos 22, 23, 24: Concave shaped glass panes, clearly visible by the bent crossbars..

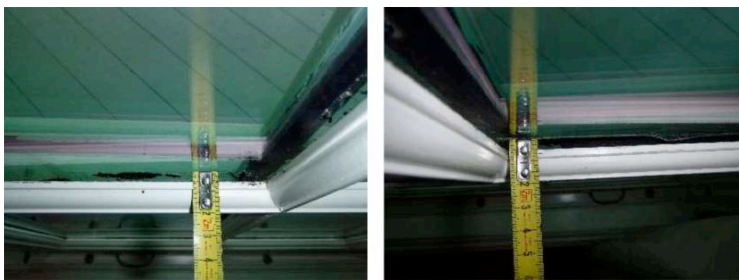
Due to the distortion of the panes the crossbars of many windows were detached from the glass pane.

Photos 25, 26: Detached crossbars with 5 mm spacing between crossbar and glass pane.

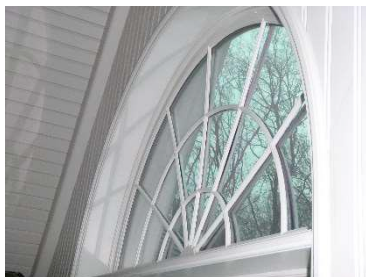
One of the larger half circle shaped units shows the touching of the panes clearly by the closeness of the crossbars as viewed from a side.

Photo 27: The closeness of the crossbars indicates touching panes and foils.

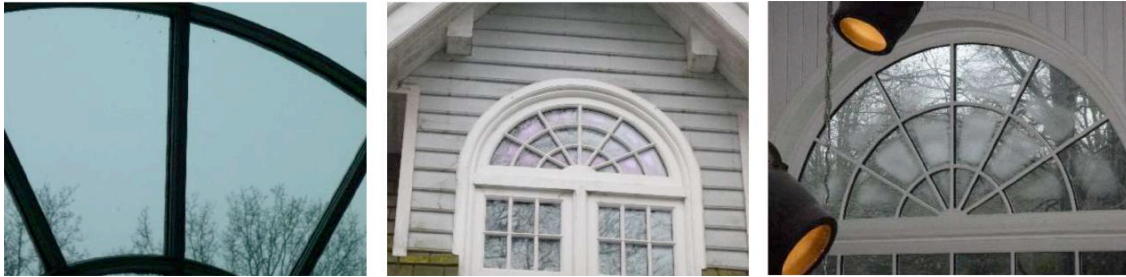
Some of the larger units show clear signs of touching foils and/or glass panes (i.e. Moiré or interference patterns and discoloration). Due to the decrease of the insulating properties of the greatly reduced cavity and the atmospheric conditions condensation patterns on the inside were visible on one unit.

Photos 28, 29, 30: Signs of touching foils and or glass panes inside the cavity: Moiré, interference discoloration and inside condensation.

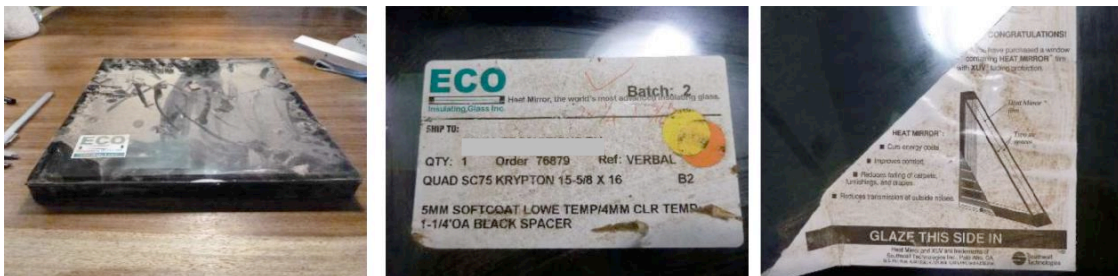
Photos 31, 32, 33: The spare IGU and its stickers.

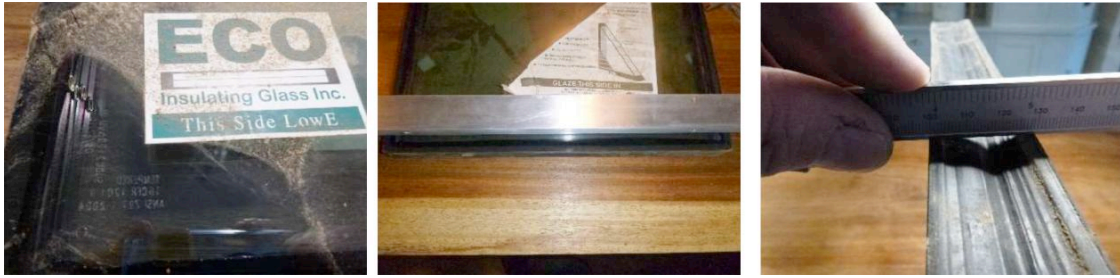
- The unit measures 396 x 407 mm.
- The distortion of the 4 mm inside pane is 3,8 mm.
- The distortion related to the diagonal and shortest side are given in tables 2 and 3.
- The spacer is curved and pulled inwards up to 4,5 mm in the centre (viewed frontally).
- The secondary sealant is distorted and shaped inwards for approximately 5 mm.

Photos 34, 35, 36: The etched markings, the inward curved spacer compared to the ruler and the inward shaped secondary sealant.

This conclusion that no external influences (or influences the owner can be held responsible for) cause the occurring damage becomes indisputable by observations made on a spare IGU that was stored inside, dry and shielded from sunlight. This unit also showed the con-cave shape an even showed deformed spacers that were pulled inwards. Both are a clear sign of a low pressure inside the unit.
